INSURING ADEQUATE OIL DRAINAGE

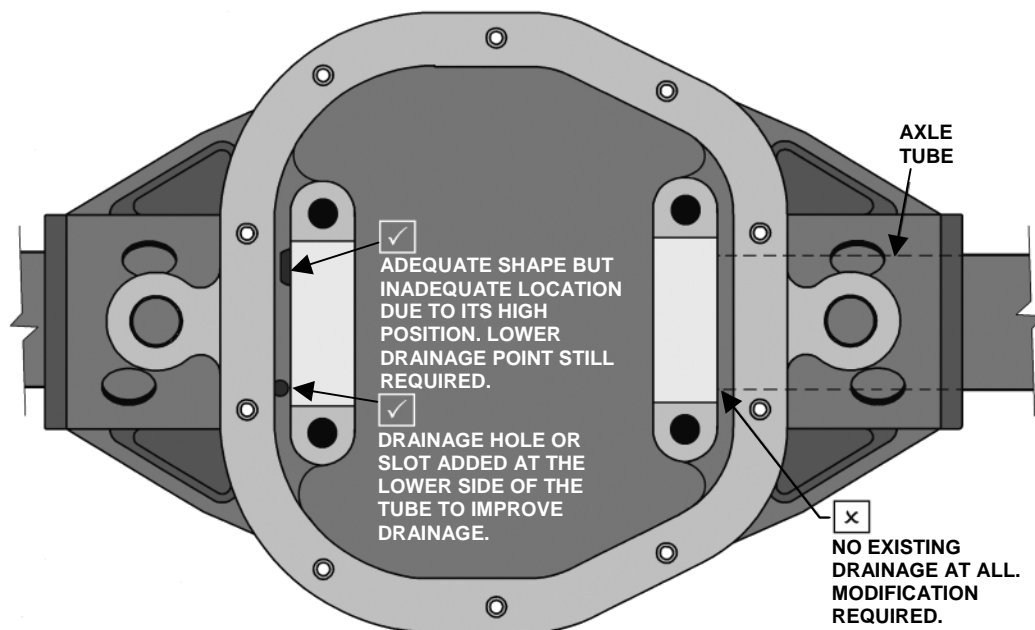
Some Dana 30, Dana 35, Dana 44 and Ford 8.8 axles were manufactured with poor oil drainage between the axle tubes and the differential housing. This can often result in one of the axle tubes filling up with differential oil while running. In most cases this will result in a blocked air vent which will cause the differential housing to pressurize and expel oil from the axle seals at the wheels or force oil into the *Air Locker* air lines, eventually expelling oil at the solenoid valve. This is a design flaw that was corrected by most automakers in the later releases of their axle assemblies.

Inspect the differential housing for the presence of adequate drainage in both axle tubes. If no adequate drainage points are present in the differential housing then it is critical that you modify the housing to include them (refer to the figure below).

Note that before any modifications it is important to cover the differential housing cavity and the axle tube openings with a rag to protect them from metal filings. Afterwards, remove any sharp edges and thoroughly clean the housing.
