OE FIX

— GUIDE —

What's an OE FIX? It's an exclusive, Dorman-engineered part that delivers value in one or more of the following ways:

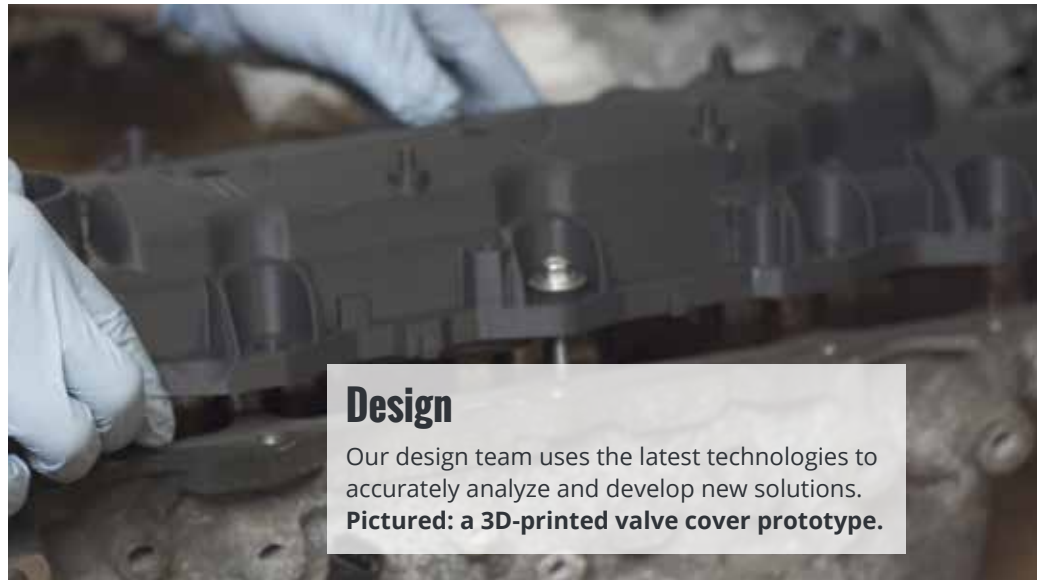
Design

Our design team uses the latest technologies to accurately analyze and develop new solutions. **Pictured: a 3D-printed valve cover prototype.**

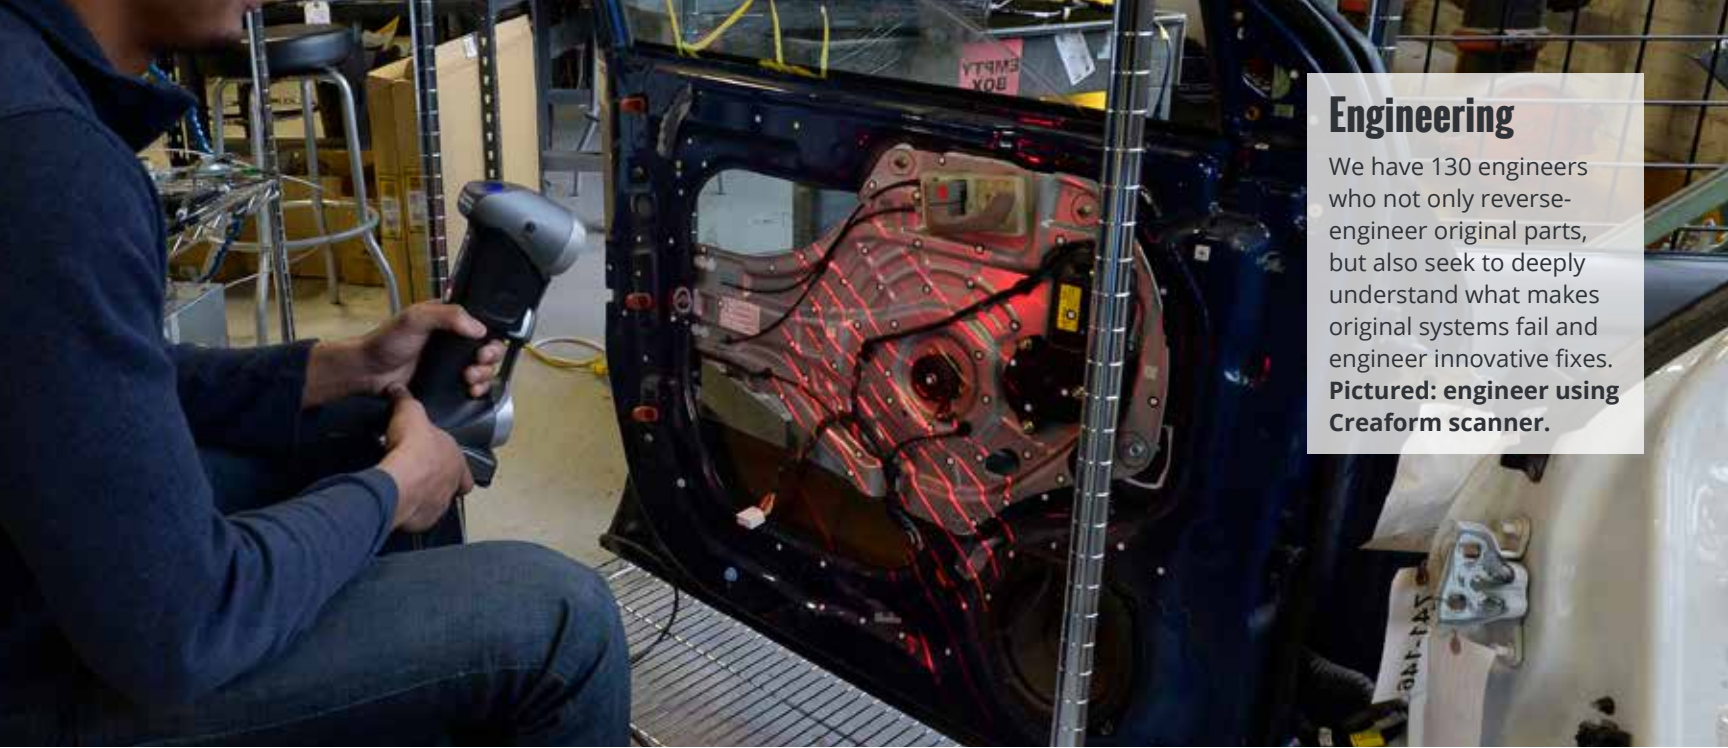
Engineering

We have 130 engineers who not only reverse-engineer original parts, but also seek to deeply understand what makes original systems fail and engineer innovative fixes. **Pictured: engineer using Creaform scanner.**

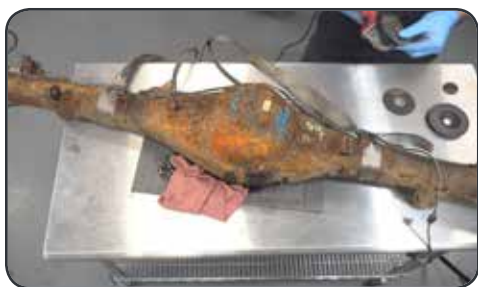
Differential Cover

Underneath 4Runner, FJ Cruiser, Tacoma and Tundra vehicles, the cap that covers the differential is made of thin-gauge stamped steel, which lets rust eat away at it faster than other areas.

The first sign of failure is typically a wet spot on the outside of the cover, or a small drip on the ground under the axle. Left to corrode further, the axle loses fluid, or water gets into the housing, mixing with the gear lube.

These covers are welded in place, not bolted on like other trucks, so they're tough to replace by themselves. In the past, you'd

The differential covers on Toyota trucks are made of thin-gauge steel that corrodes faster than the rest of the rear axle housing. With their weld-on design, the dealer's only solution is an entire new axle assembly.

We built a replacement differential cover that can be welded on while preserving the original axle assembly. It also features heavier-gauge steel for a longer service life, and arrives ready to install with a weld-through primer finish.

That's why Dorman designed OE FIX replacement differential covers for Toyota trucks. They're made of heavier stamped steel for greater rust resistance, and come pre-primed.

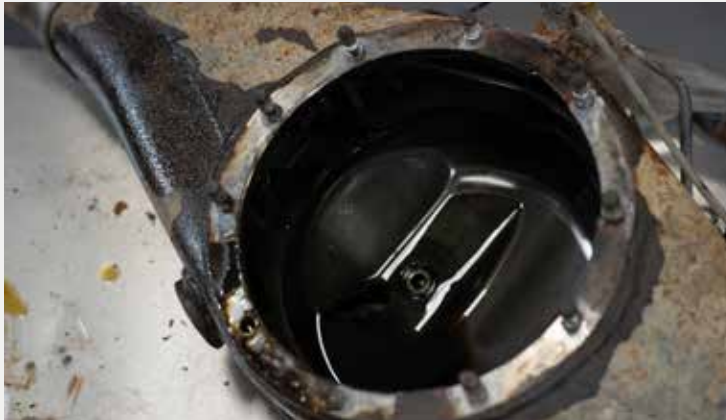
1 Remove the axle unit from the vehicle, following the workshop manual. After removing the axle shafts and differential, drain the gear lube.

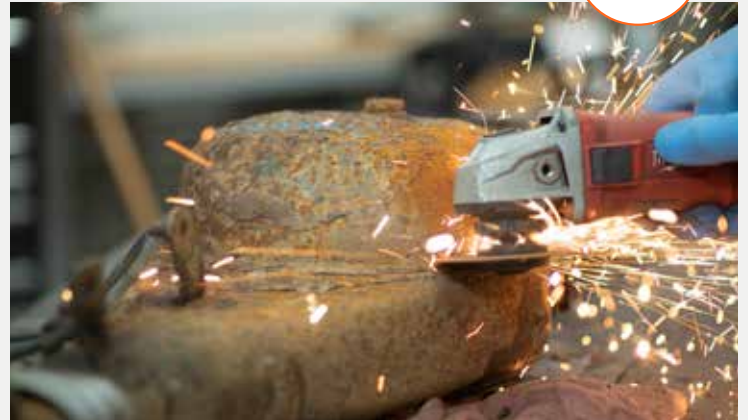
2 Carefully cut through the original differential cover using an electric or pneumatic cutoff wheel, around the circumference of the cover.

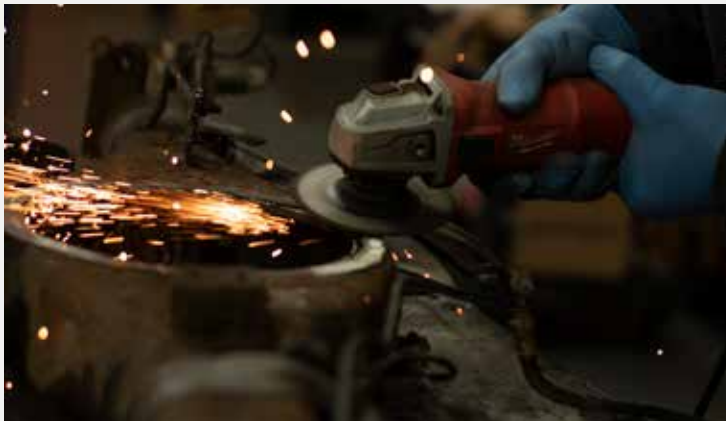
3 Use an angle grinder to clean up the mating surface where the new cover will be installed.

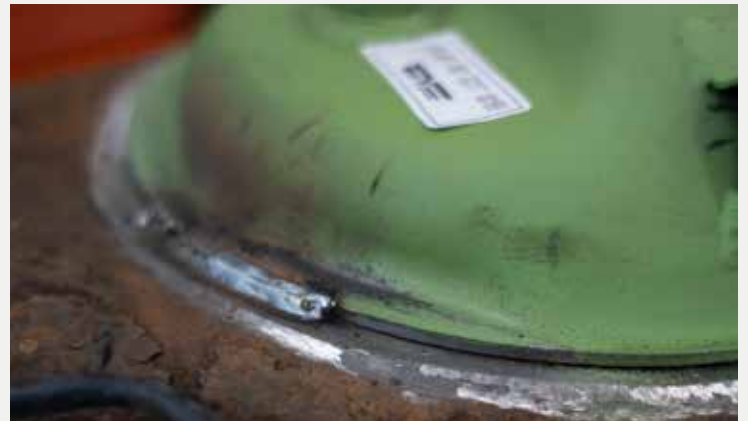
4 Carefully position the new cover in place, being sure to orient it correctly. Using an appropriate welder, tack the new cap in position initially.

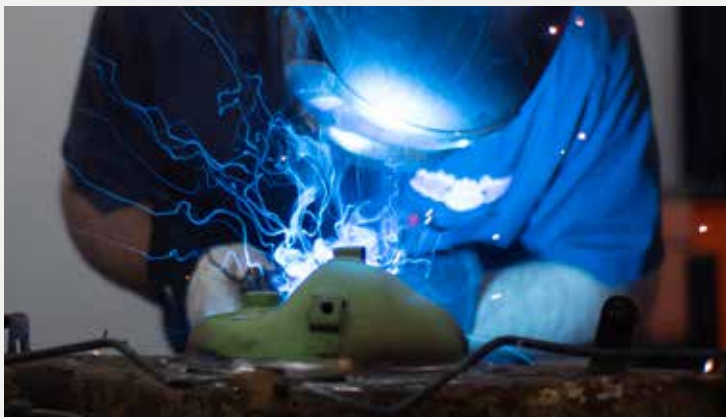
5 Run a continuous bead weld around the circumference of the new cover, making sure there are no gaps in the weld.

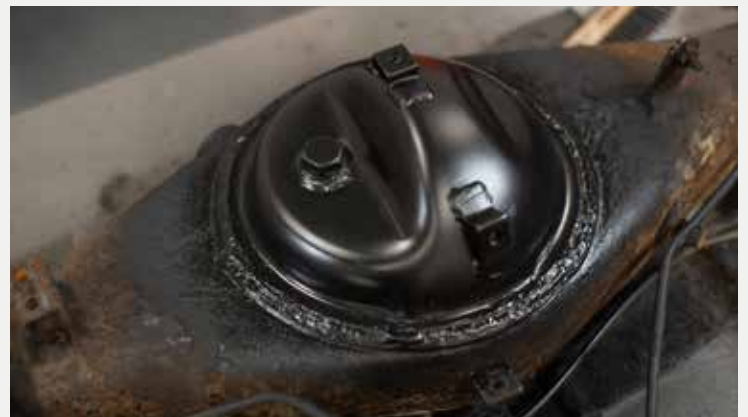
6 Once cool, degrease the work with a pre-paint solvent. Apply self-etching primer, and finish with a coat of chassis paint to prevent future corrosion.

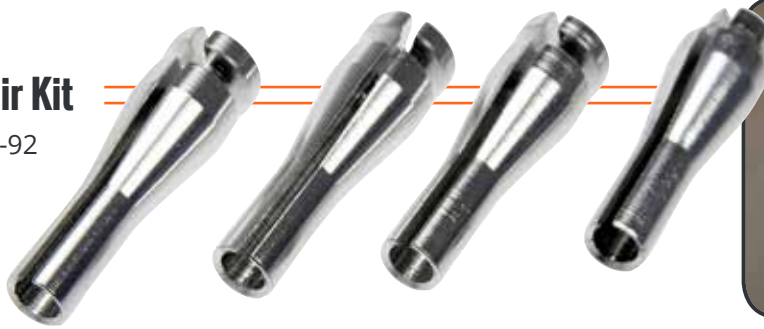
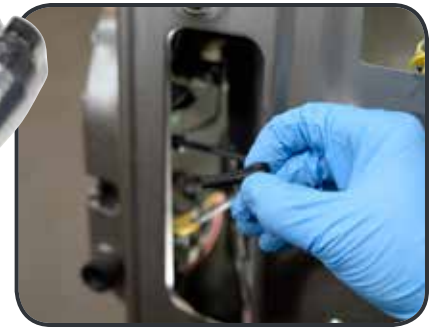
926-111 Ford trucks 2017-92

Door latches often fail because of simple faulty latch cable ends. Trouble is, there's usually no easy way to fix just those failed pieces. You're stuck replacing the whole assembly.

This door latch cable repair kit includes four door cable ends for easy repairs of this common failure, saving time and money.

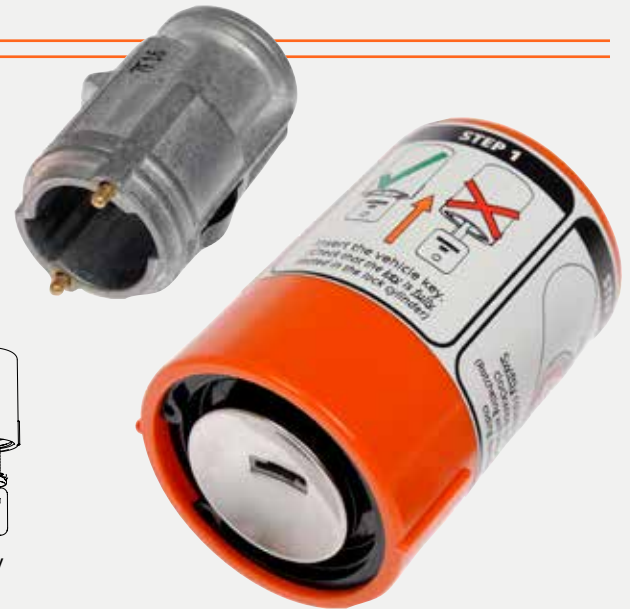
924-784 Chrysler 2007-98, Dodge 2009-98, Jeep 2005-98, Plymouth 2001-97

Replacing an ignition lock cylinder usually requires the tedious, manual process of disassembling and reassembling individual lock wafers in order to maintain the original key.

This patent-pending design revolutionizes the process of replacing and recoding an ignition lock cylinder. Insert the key into the lock cylinder, turn it twice and remove the cylinder. No time wasted at the dealer to get the new cylinder matched to the original key.

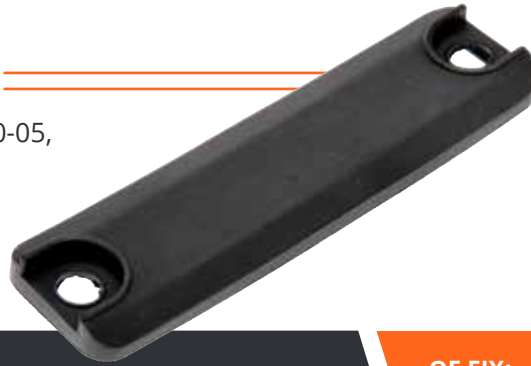
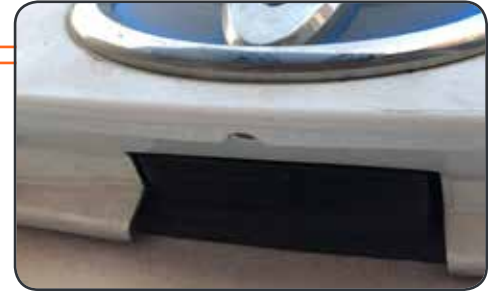
926-098 Lexus 2012-04, Scion 2010-05, Toyota 2017-03

Liftgate switch seals often wear out, letting in water, dirt and debris, which can damage the switch. It's a simple piece of rubber, but you usually have to replace the whole switch just to get the seal replaced.

We reverse-engineered the exact seals on certain vehicles' liftgate release switches, allowing for a cost-effective, simple fix.

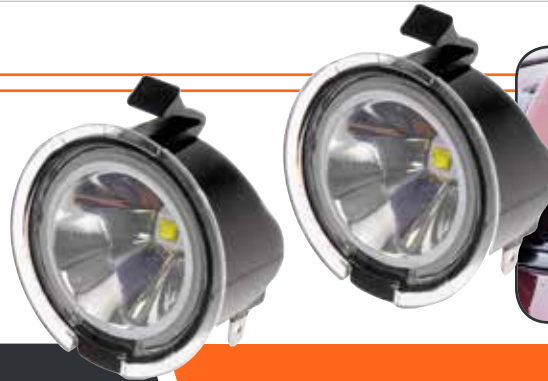
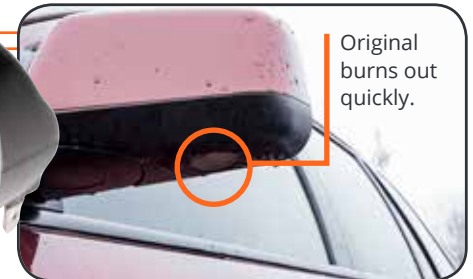
926-107 Ford, Lincoln 2018-03, Mercury 2009-08, Mercury 2005-03

Original burns out quickly.

The original puddle light on certain vehicles has an incandescent bulb that burns out quickly, making for an annoying recurring problem.

We upgraded the bulb to an LED, offering increased brightness and longevity.

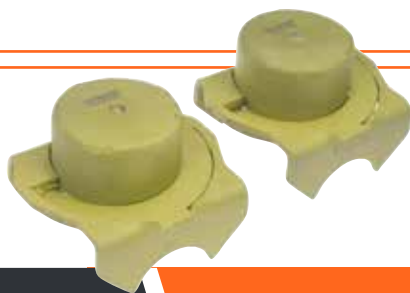
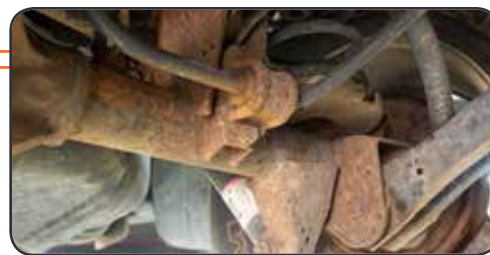
523-280 Jeep Wrangler 2015-07

When a coil spring mount breaks or corrodes, you usually only have one choice - replace the entire axle assembly. That's a lot of unnecessary time and expense.

We reverse-engineered the coil spring mounts, allowing you to simply replace the failed original part. We also coated them with weldable primer to ensure a clean installation.

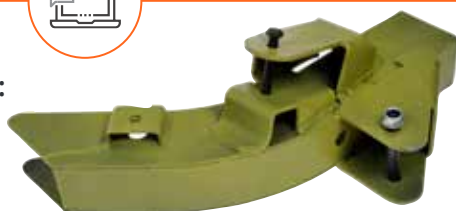
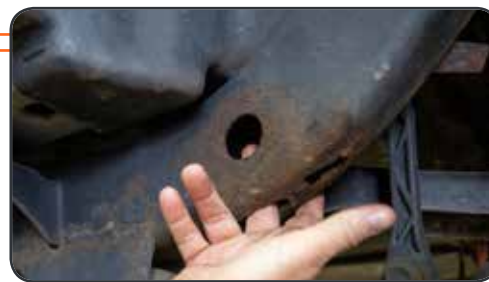
523-282 Jeep Wrangler 2003-97

Frames rust from both regular use as well as off-roading. Although common, fixing a rusted frame has typically been an expensive repair.

Our frame repair kit makes it simpler to replace a failed frame section. Made of heavy-gauge steel and finished in weldable primer, it includes all OE hardware mounting positions, with redesigned drainage to prevent future corrosion buildup.

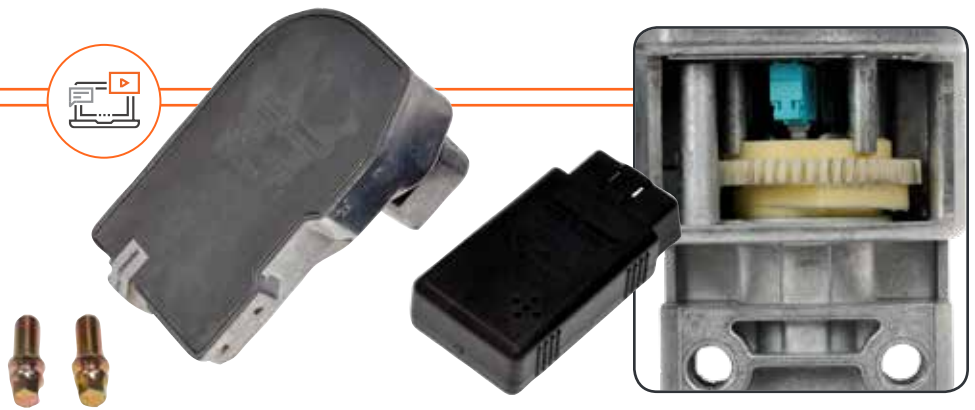
601-037 Infiniti 2013-09, Nissan 2017-07

The steering column lock actuators on many vehicles fail because their internal gear teeth wear out. When that happens, it prevents the starter interlock switch from disengaging and the car won't start.

We upgraded the gear teeth to a stronger compound for longer service life, tested to more than 15,000 cycles. We also updated the software to adjust the gear speed and minimize gear teeth wear in the future.

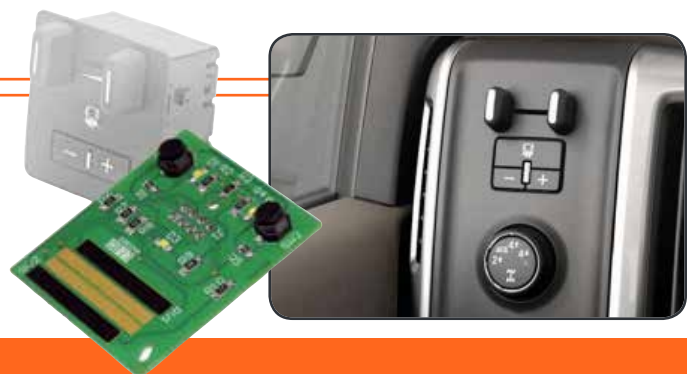
Trailer Brake Control Module Circuit Board

OE PROBLEM:

When the original module fails, the only solution is to replace the complete module assembly.

We offer a separate replacement circuit board, restoring proportional braking and other critical functions, at a fraction of the cost.

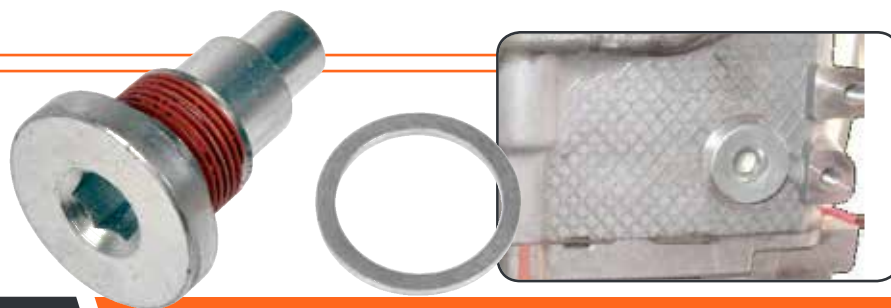
Engine Timing Chain Guide Bolt

OE PROBLEM:

It's usually bad news when the timing chain guide bolt shears off. It typically means replacing the entire cylinder head during installation, a long, expensive process.

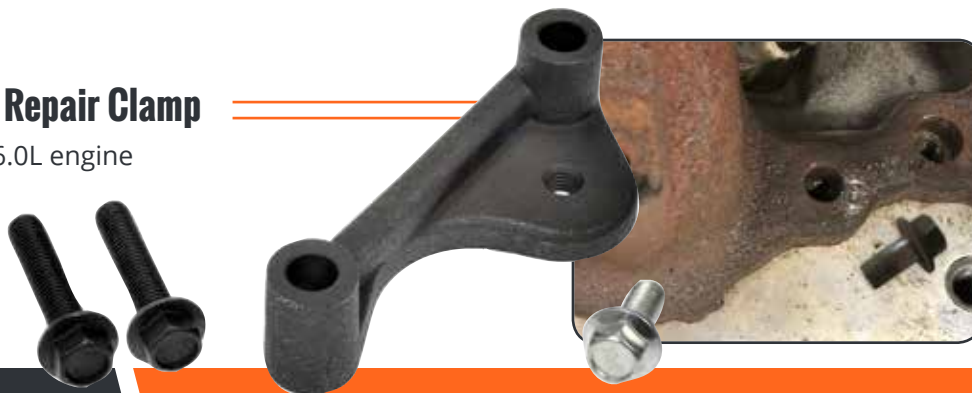
917-108 GM trucks 2009-99; 4.8L, 5.3L, 6.0L engine

When a manifold bolt breaks, you usually have to remove the entire cylinder head.

This exhaust manifold to cylinder head clamp is our exclusive solution, allowing you to fix exhaust leaks without removing the broken manifold studs, and create a firm seal between the exhaust manifold. The clamp comes with bolts for a complete repair.

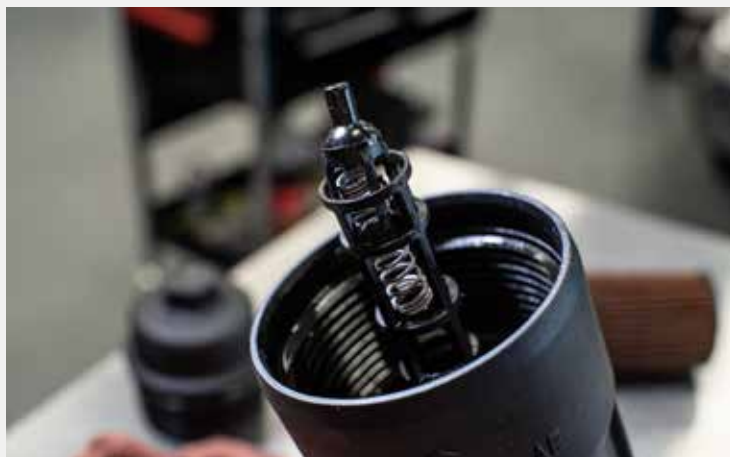
1 Remove the filter, and examine the tip of the bypass valve. The tip may be deformed or will be resting in a tilted position.

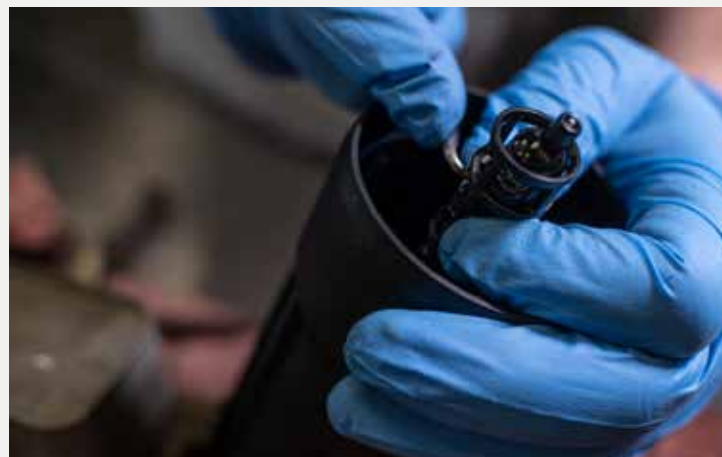
2 Grab the spring-loaded tip near its edge, using a pair of pliers, and carefully pull upward to release it.

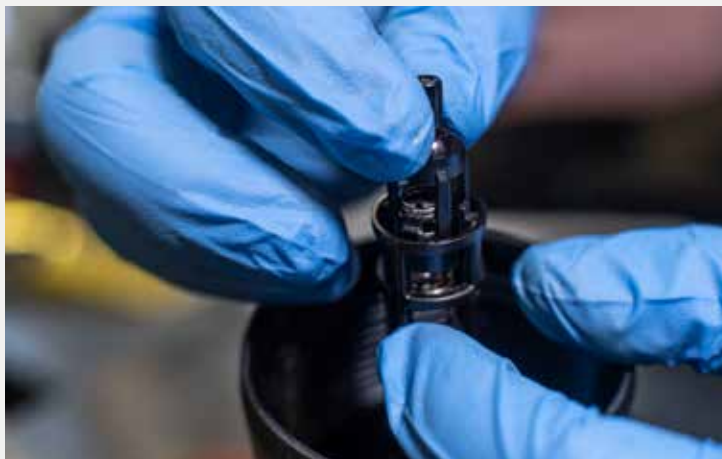
4 Insert the new spring into the valve support, and press the new tip into place before replacing the oil filter.

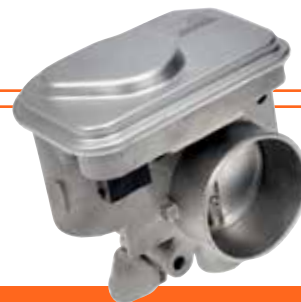
Fuel Injection Throttle Body

OE PROBLEM:

Electronic throttle body assemblies frequently require replacement due to internal electronic sensor and gear failures.

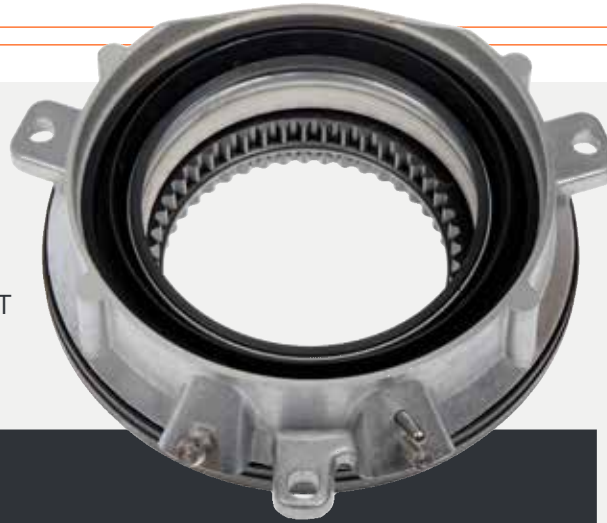
600-405

Failed wheel end actuator

The original wheel end actuator on certain vehicles is highly failure prone, leading to a loss of vacuum, and an inoperable 4WD system.

We found that the hub locking actuator created significant problems without adding much value for many owners. This patent-pending vacuum delete kit restores critical operation, while eliminating failure-prone features, and adding increased durability and serviceability.

The internal diaphragm on these parts wears out from regular use, or cracks from lack of use, as well as poor internal lubrication. The grinding happens when the splined actuator doesn't have the vacuum it needs to fully engage the axle shaft. Eventually the vacuum leak expands, preventing the system from working at all.

With that realization, our engineers built a first-of-its-kind independent wheel end coupler vacuum delete kit. Designed to be replaced as a pair, this patent-pending product looks and fits like the original, but simply establishes a robust, permanent connection between the two components. It also includes vacuum caps on the hub, for holding the remnant vacuum lines, in case the owner ever wants to revert to the original design in the future.

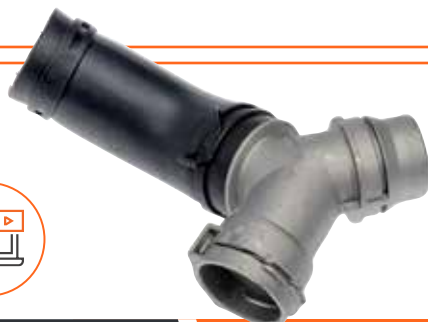
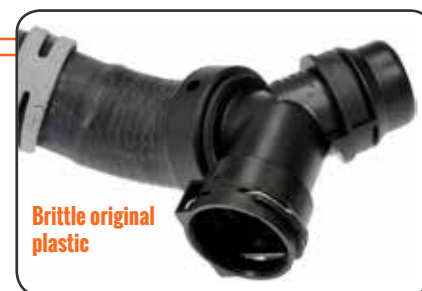
HVAC Heater Hose Assembly

OE PROBLEM:

The Y-connectors on many HVAC heater hoses are made of brittle plastic that eventually cracks and leaks. These simple pieces can become big headaches if you're replacing them again and again.

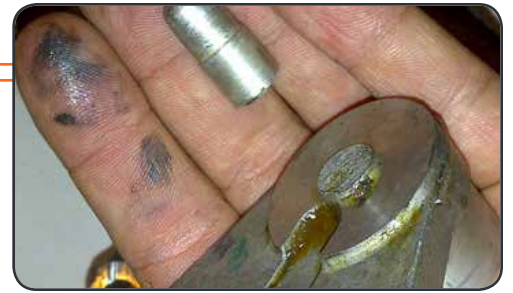
600-114 GMC Envoy, Chevrolet Trailblazer, Saab 9-7X, Isuzu Ascender 2009-02

4WD actuator forks routinely fail when the alignment pins break and the contact pads become worn out.

We engineered our replacement shift forks with extended alignment pins to prevent future breakage, a third contact pad for greater support around the bearing area, and forged aluminum instead of brittle cast aluminum.

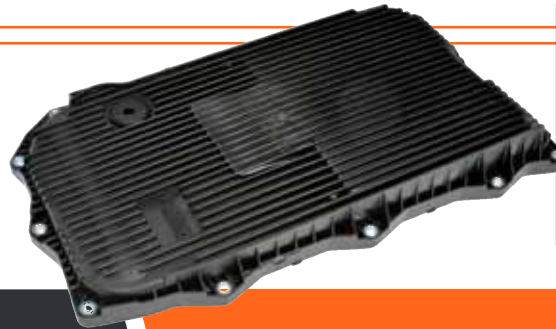
265-853 BMW 2018-10, Chrysler 2018-12, Jaguar 2019-13

OE PROBLEM:

When the original transmission fluid filter on certain vehicles requires service, you're usually stuck replacing the entire transmission oil pan.

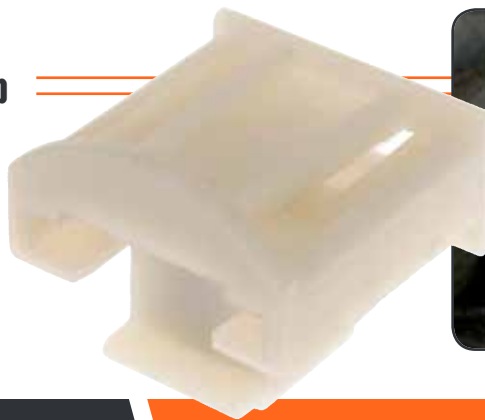
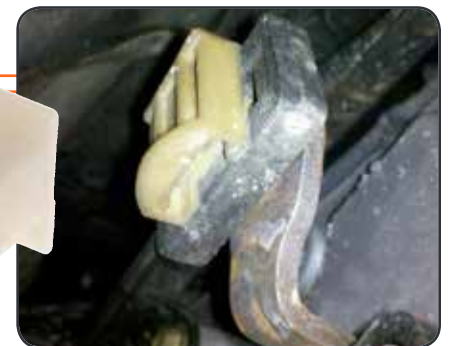
Automatic Transmission Shift Linkage Clip

OE PROBLEM:

The transmission shift linkage clips on many Ford models break easily, disabling the shifter mechanism. You usually don't have a choice but to buy a whole new shifter cable assembly.

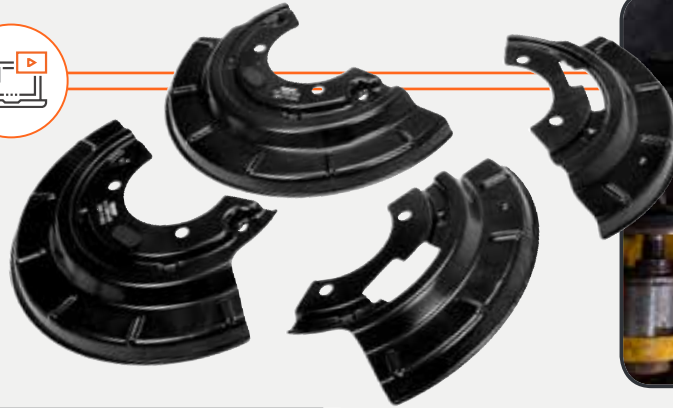
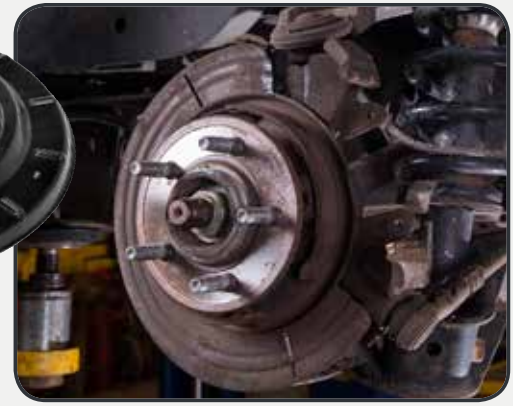
924-662 Ford Escape,
Mercury Mariner 2007-05

OE PROBLEM:

Brake dust shields do a good job of keeping debris out of a vehicle's brakes, but when the shields themselves corrode, replacing them can be labor intensive if you have to remove the whole axle shaft and the wheel hubs.

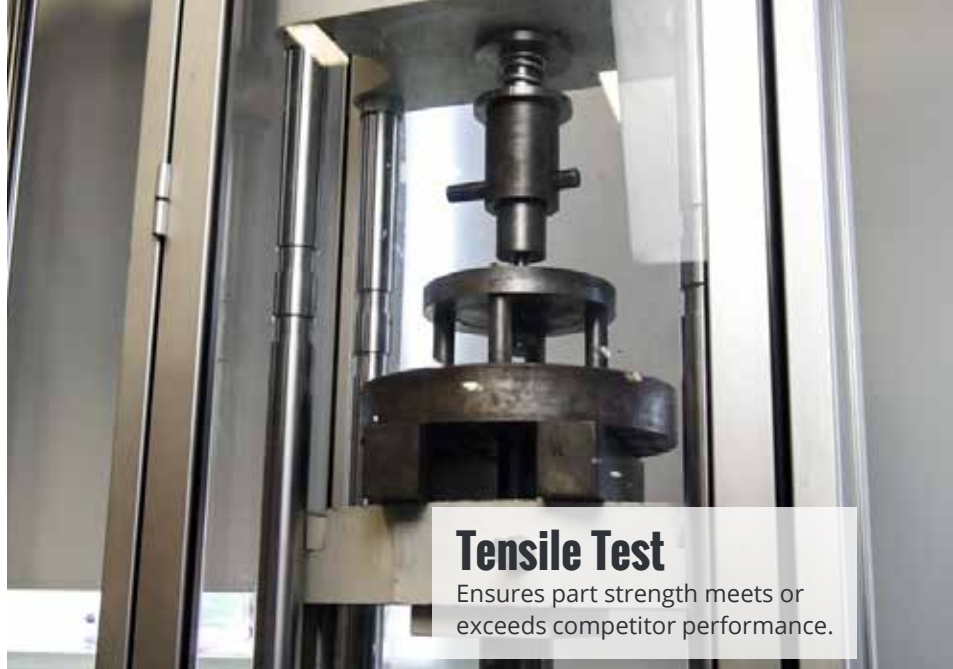
Tensile Test

Ensures part strength meets or exceeds competitor performance.

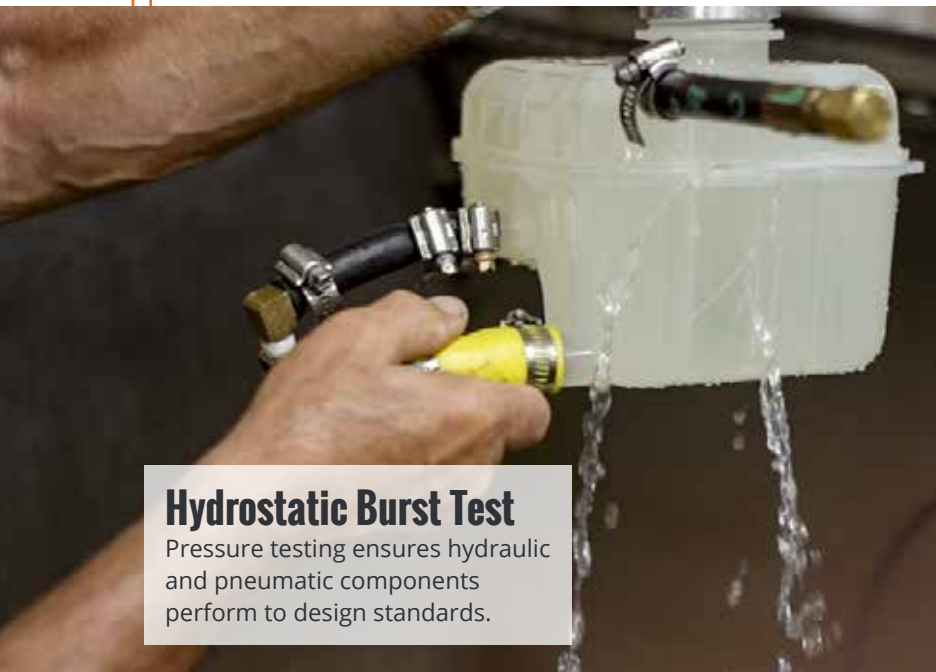
Hydrostatic Burst Test

Pressure testing ensures hydraulic and pneumatic components perform to design standards.

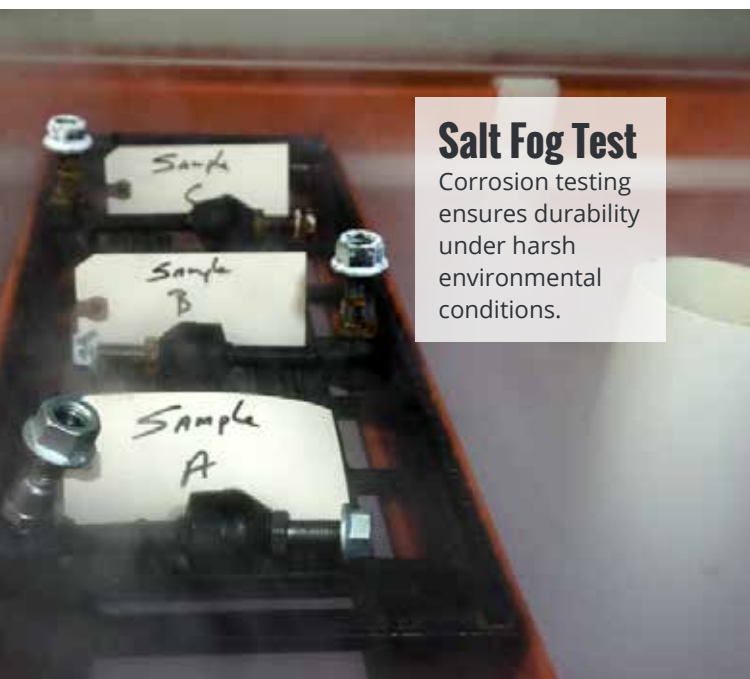
Salt Fog Test

Corrosion testing ensures durability under harsh environmental conditions.
