INSPECTION FOR BENT AXLES

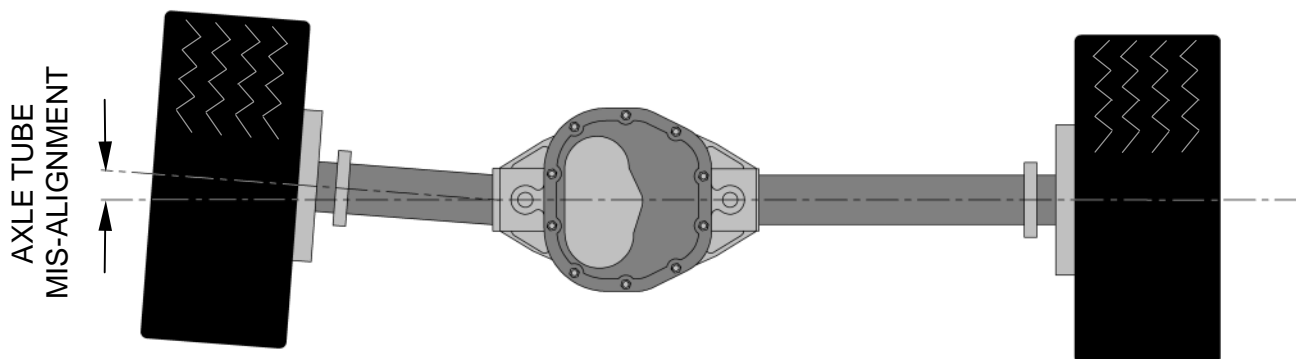
Collision damage or heavy off-road use of your vehicle in the past may have resulted in some degree of bending in the axle tubes. The figure below, although exaggerated, shows the misalignment of the axle tubes. ARB strongly recommends that you have your axle assembly inspected for concentricity and straightness before installing your Air Locker as any misalignment may result in excessive wear and/or failure of your differential and axle shafts.

- The cross shaft broken adjacent to the front edge of the pinion.
- Excessive wear on the side gear seats.
- Excessive wear on the axle splines.
